### Summary

This technical note outlines a study performed to test the integrity of common BDS bottles after subjecting them to freezing down to cryogenic temperatures followed by a drop from 3 feet (1 m). Bottles are observed to ensure structural integrity after freezing and then dropped from a typical countertop height to see if bottle integrity is maintained. Finally, they are inspected post-thaw for any leaks or other structural damage that is undetectable when frozen.

## Bottle Freeze Drop Test Procedure

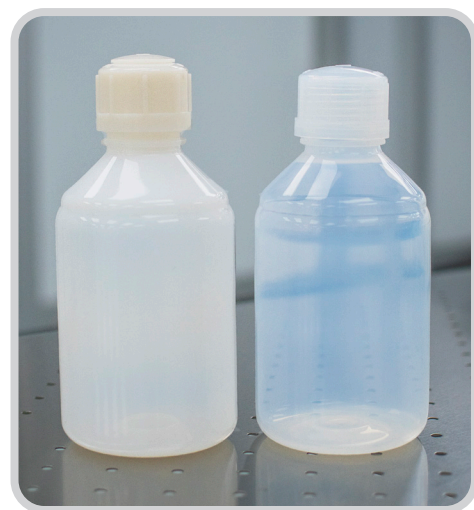
*Savillex Purillex<sup>®</sup> ETFE and PFA 1 L Bottles*

The container closure system of Purillex® fluoropolymer bottles has a superior design, which ensures a better seal and better protection of contents even under blast freeze conditions. The identical fluoropolymer resin type and grade are used for both bottle and closure, and both bottle thread and closure are injection molded, ensuring precise fit and superior seal integrity without the need for a closure insert. This means that only a single material is in contact with the product.

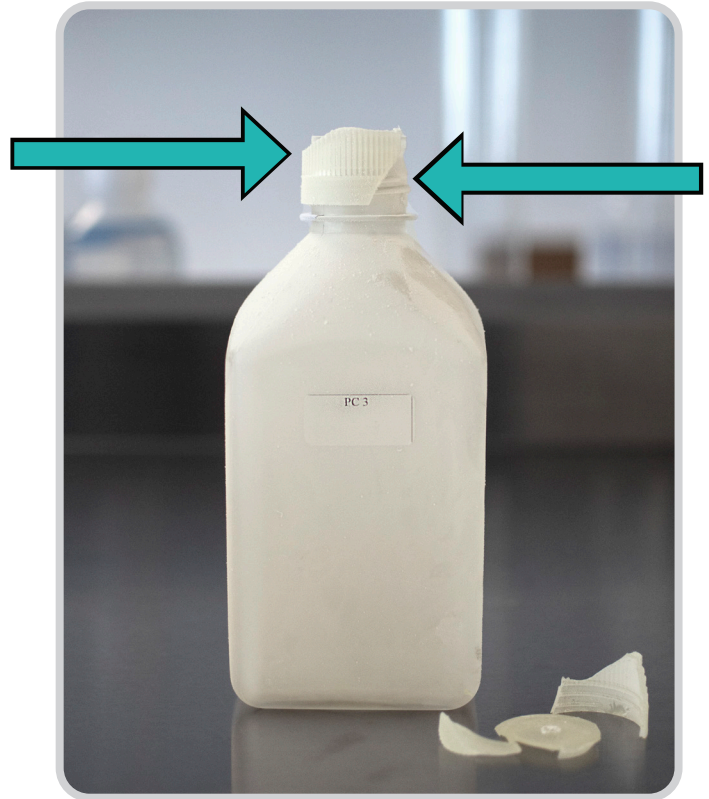
Figure 2: PC Closure Damage – Flat-on-Bottom Drop

Six of the seven PC bottles survived drops with no damage. One bottle, after the initial flat-on-bottom drop, fell to the side, hitting the closure on the cement floor, causing it to shatter (Figure 2). It was discovered later that the closure was made from polypropylene and was not suitable for use at cryogenic temperatures.

7	PETG	<b>Crack from bottom corner to side to top</b>	
1	PC	No leaking; no paneling after thaw	
2	PC	No leaking; no paneling after thaw	
3	PC	<b>PP closure shattered during flat-on-bottom drop</b>	See Figure 2
4	PC	No leaking; no paneling after thaw	
5	PC	No leaking; no paneling after thaw	
6	PC	No leaking; no paneling after thaw	
7	PC	No leaking; no paneling after thaw

Conversely, all PETG bottles failed the drop test, and one of six PC bottles failed due to an incompatible closure made from a different material. Because of these failures, we do not recommend using commercially available PETG nor PC bottles for cryogenic storage of critical materials like BDS.
